**Town of Grafton, Massachusetts Fire Department**  
**Fire Apparatus Fleet Review and Assessment**

# **TOWN OF GRAFTON FIRE DEPARTMENT APPARATUS FLEET REVIEW**

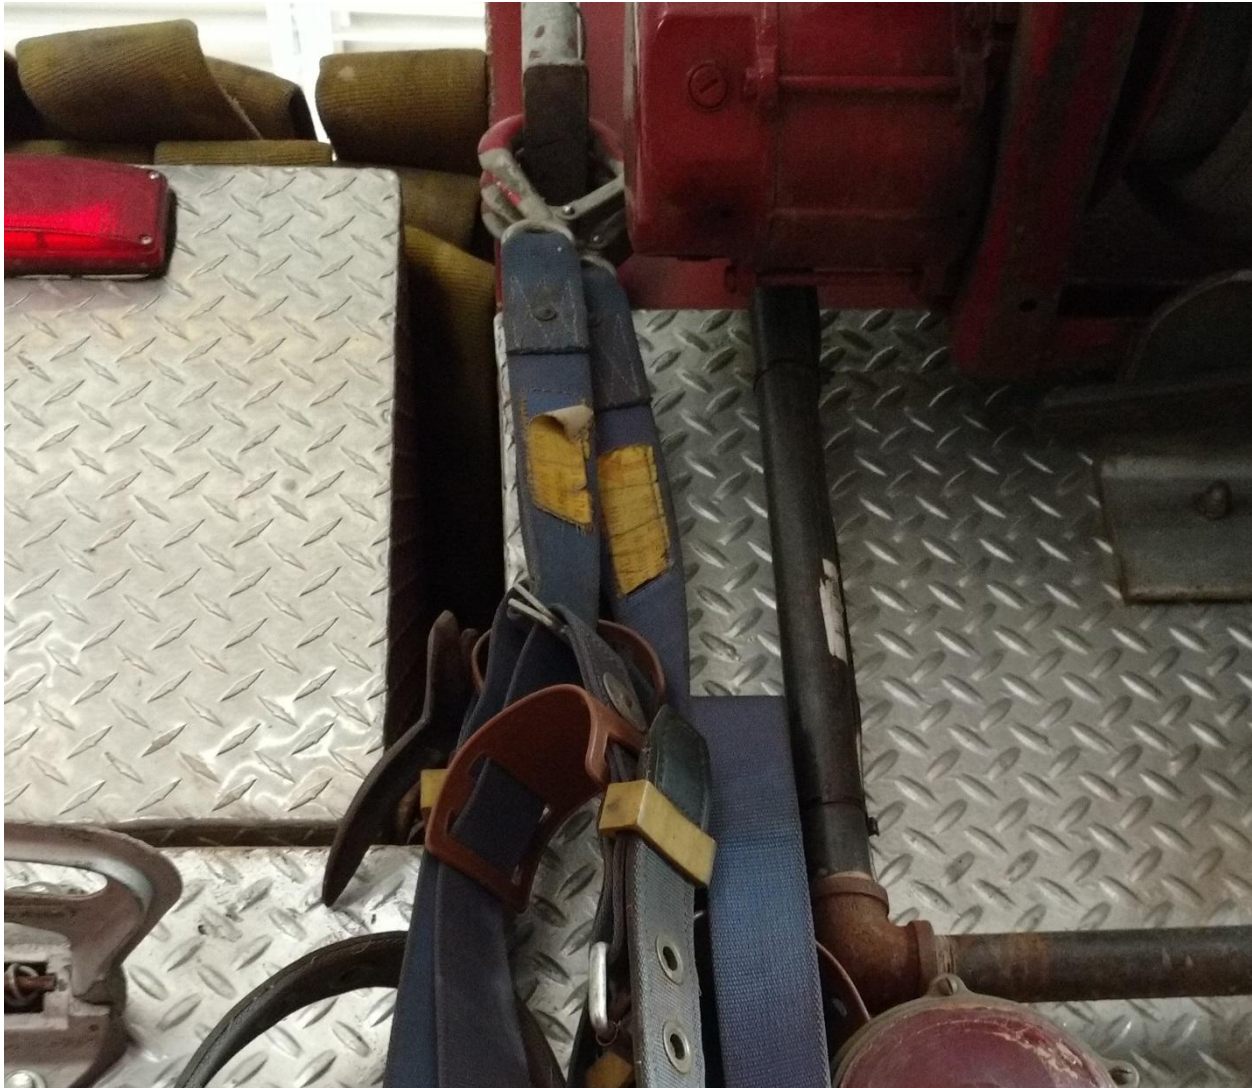
**Image 7.1 Safety belts carried at the rear step on Forestry 1  
No personnel should be permitted to ride on the side or rear of any wildland  
vehicle at any time**

- 7. The ladder belts carried at the left, rear of Forestry 1 should be removed from service and not replaced. The presence of these belts would indicate that personnel are permitted to ride and operated on the exterior of this vehicle. No personnel should be permitted to ride, stand or operate on the exterior of any vehicle in the Grafton Fire Department fleet at any time.*
